Towards understanding wind-driven hail events, with a focus on Canada

S.L. Eng¹, J.C. Brimelow², G.A. Kopp³

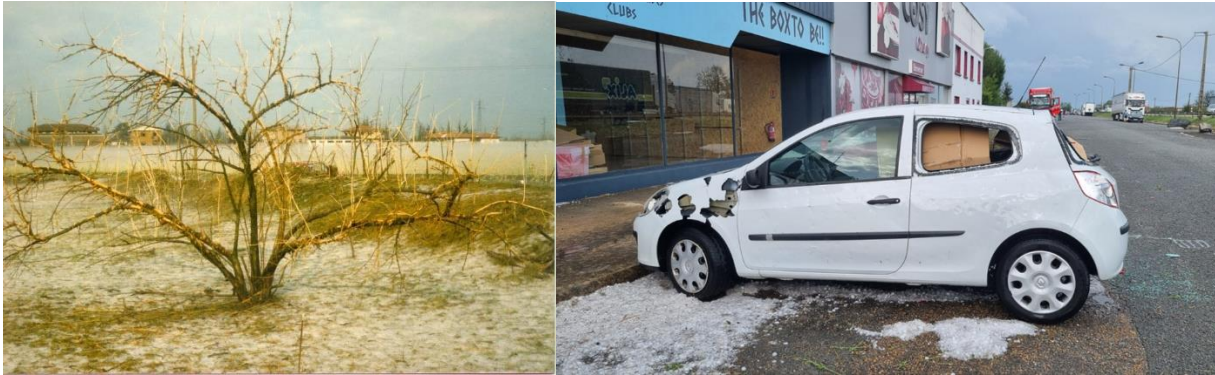
Figure 1. Debarking of a tree (left) from a WHE in Casorezzo, Italy, on 18 August 1986 (image courtesy @PavanFederico00 [Twitter]) and severe damage to a vehicle (right) from another WHE in Digoïn, France, on 22 June 2022 (photo taken by Christophe Asselin [Chroniques Chaotiques]).

The majority of the literature on hail impacts (rightly) focuses on hail damage to roofs, vehicles and crops, from mainly vertical hail trajectories, focusing on terminal fall velocity and other indicators of hail damage (see Fig. 1). No such widely available research and guidance exists for impacts to siding, windows and building envelopes from wind-driven hail events (WHEs; T. Marshall, pers. comm.). This lack of research represents a gap in our understanding of WHE risk. Additionally, for risk modelling, we need to ascertain whether WHEs are more common in some hail-prone regions than in others.

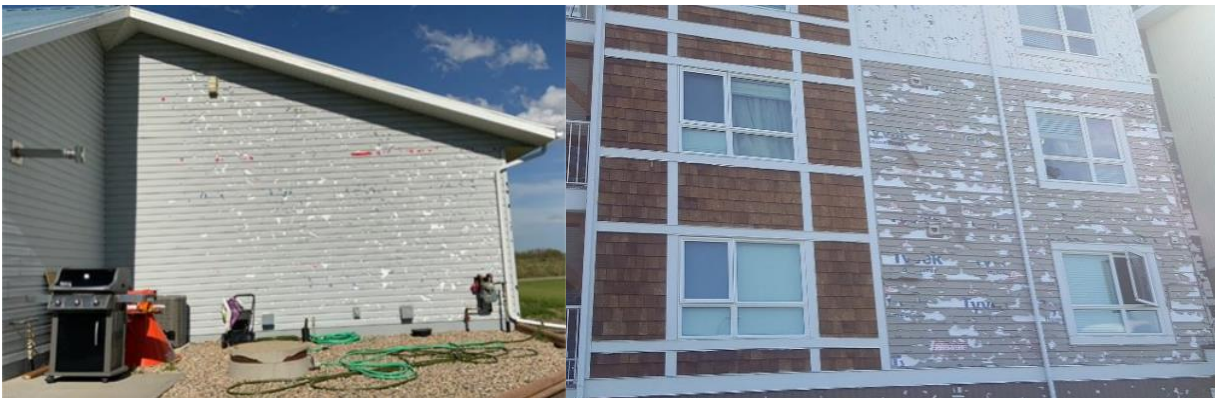
Figure 2. Severe vinyl siding damage (right-hand side wall only) (left) and contrasting damage to wooden and vinyl siding (right) on surfaces exposed to wind-driven hail.

generate damage reports of the same severity. The WHEs were characterized by high concentrations of 4–6 cm hail and were accompanied by winds approaching or exceeding 90 km h^{-1} . This combination resulted in severe damage to crops and the siding and windows of buildings (see Fig. 2).

Canada’s first billion-dollar hailstorm occurred in Calgary, Alberta on 13 June 2020, when 5–6 cm hail was accompanied by winds exceeding 70 km h^{-1} . The result was devastating damage to vehicles and the siding (see right-hand panel in Fig. 2), roofing and windows of houses. Below, we highlight this event along with multiple WHEs that were documented by the NHP in 2022. These events, along with several “probable” cases (possible WHEs requiring additional study to confirm their nature) and several “null” cases are summarized in Table 1.

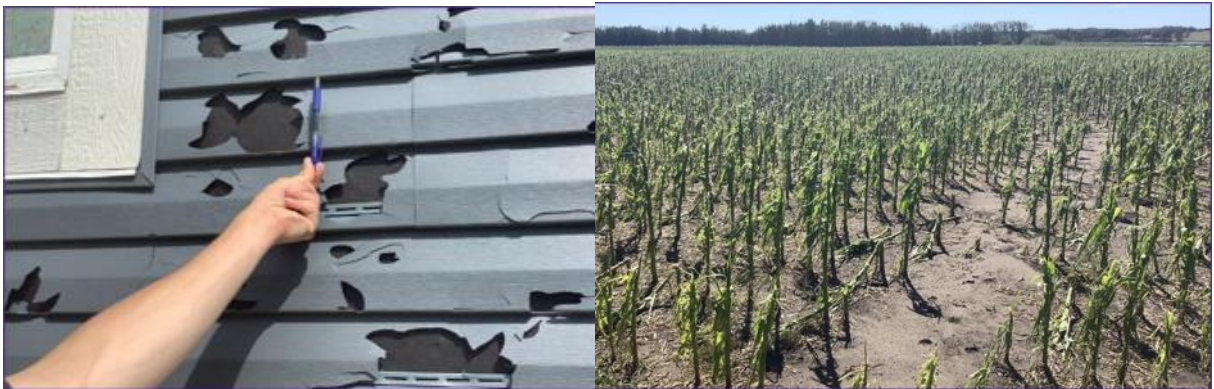
Figure 3. Severe vinyl siding damage (left) and 100% loss of corn crop (right) west of Ponoka, Alberta.

A detailed ground survey (see Fig. 3) conducted following the 16 July WHE in Ponoka found that the most severely damaged homes suffered intrusion of hail, water and tree debris through broken windows. Additionally, water intrusion through a combination of severely damaged siding and exterior wall insulation in conjunction with wind-driven rain was observed. Crops, including canola, grains and corn, suffered 100% losses; wind damage to trees nearby the 100% crop loss indicated winds had approached 80–90 km h⁻¹. An 85 km h⁻¹ gust was measured by a nearby (~20 km) Alberta Climate Information Services station located within the hailswath.
