Full-scale wind loads on flashing

Christopher Sanders¹, Murray Morrison²

SUMMARY:

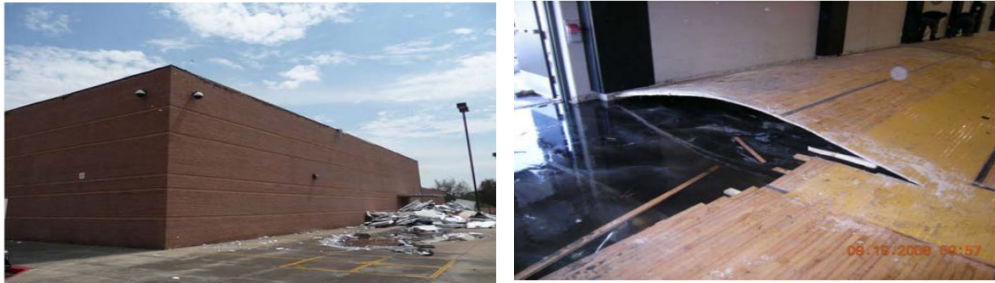
Figure 1 RICOWI, Inc. 2007. "Hurricane Ike Wind Investigation Report." Roofing Industry Committee on Weather Issues Inc., Powder Springs, Georgia. The flashing system became disengaged from the cleat, the fully adhered EPDM membrane did not peel back, but still allowed enough water to come through the header of the wall.

When flashing fails it exposes small gaps in the construction of the building which can allow air and water infiltration into the interior of the building. Additionally, that failure then also allows the single ply membrane to act as a sail in the wind and begin to peel back exposing additional areas of the roof that water can then infiltrate. Figure 1 shows the damage caused to a gymnasium floor after Hurricane Ike removed the flashing system but did not peel back the membrane. In this instance the flashing system came disengaged with the cleat due to corroded fasteners. Despite the relatively small, exposed area, water was still able to penetrate through the header of the building and cause extensive damage to the interior of the building (RICOWI 2007).

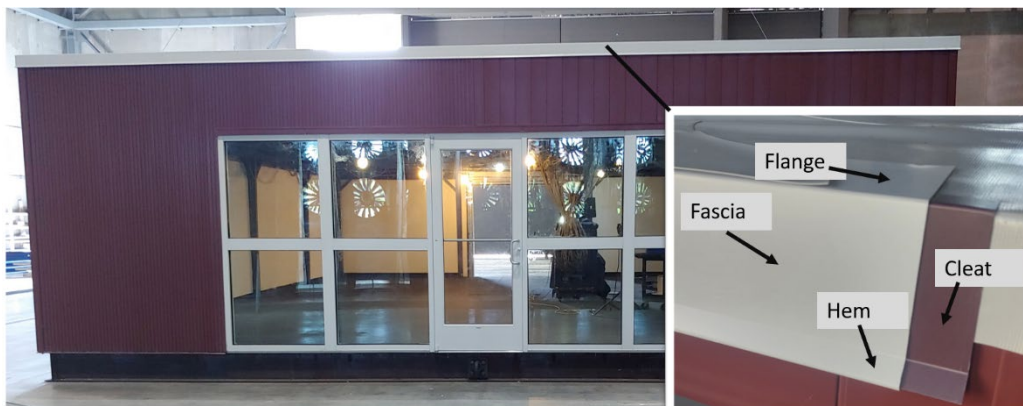
Figure 2 Flashing systems are composed of two layers: the interior cleat (maroon in the picture) and the exterior portion (white) which is broken up into three parts. The hem section connects to the cleat by tensions, the fascia section extends vertically down the wall of the building, and the flange section runs horizontally along the roof and is held down by fasteners.

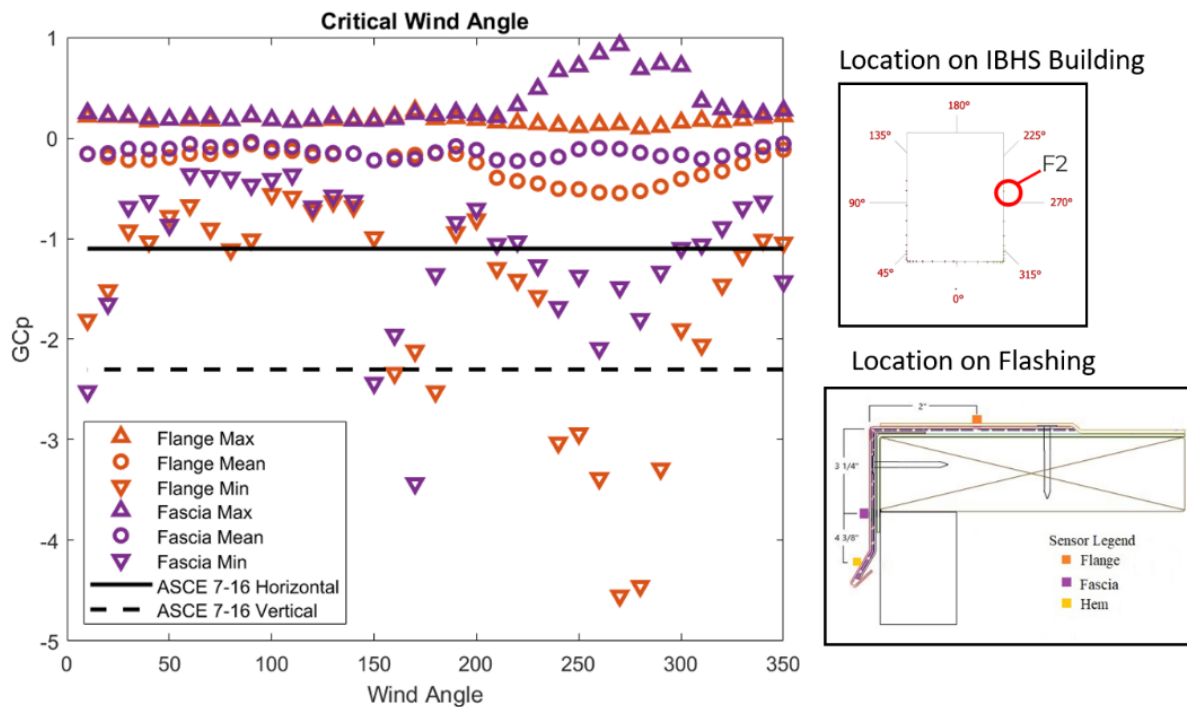
Figure 3 Critical wind angle for the flange (horizontal) and fascia (vertical) sections of the flashing system over 36 wind angles.

ASCE 7-16 gives guidance for what pressure loads should be used when designing a building. GCp values given by ASCE 7-16 are based on model scale wind tunnel testing where the pressures experienced by small components like flashing cannot be scaled down without changing the material properties. Figure 2 shows the detail of one of the flashing systems used in this study. Figure 3 shows the GCp values of the wind loads experienced by the vertical (fascia) and horizontal (flange) segments of the flashing as well as their respective ASCE 7-16 values. The GCp values presented in Figure 3 are from the flashing sensor location F2, across all wind angles. While the mean external loads fall within the ASCE 7-16 values, the minimum loads exceed their respective ASCE 7-16 values on both the flange and fascia section of the flashing. The highest suctions occur on the flange between wind angles 250° - 290°. However, for both the flange and fascia the GCp values from ASCE 7-16 for their respective sections were exceeded. GCp on the fascia and flange also exceeded their respective ASCE 7-16 values between wind angles 0°/360°-30° and wind angles 150°-180°.
