# Rapid Repair Demand Estimation Method for Damaged Residential Roofs Under Wind Disaster Using Remote Sensing Images and Machine Learning

## SUMMARY:

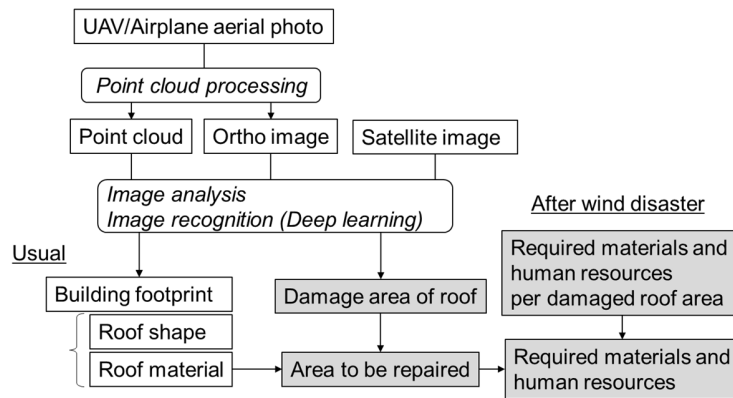
Figure 1. Flowchart for estimating roof repair demand.

The flow of roof repair demand estimation is shown in Figure 1. First, a point cloud and an ortho image are generated based on aerial photos taken from UAV's and/or airplanes before disaster. Second, using the generated point cloud and the ortho images, footprints, roof shapes and roof materials of residential houses are specified. Once a disaster occurs, aerial photos are taken or satellite images are collected, which are then utilized to identify the locations/extent of damage to roof of each target house located in areas in concern. Then, by supposing the building information such as footprint, roof shape and roof material with the identified locations/extent of roof damage, the types and the amount of building materials and the amount of human resource required for repair work is estimated. Here, the data on actual repair work obtained for the damage due to typhoon Jebi in 2018 is utilized in order to estimate human resource based on the identified locations/extent of roof damage.

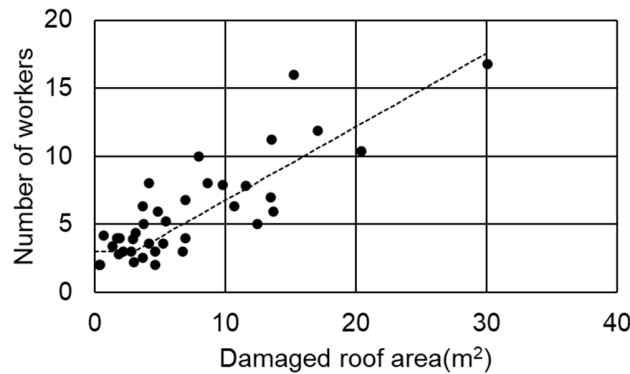
**Figure 4.** The relationship between the area of roof and the human resources required for repair.

The relationship between the area of roof and the human resources required for repair is estimated from the data collected by a local government, which was affected by typhoon Jebi in 2018. Figure 4 shows the estimated relationship. Around 3.0 man-day is required for repair with areas of less than 3 m<sup>2</sup>; however, for extended roof damages, the man-day increases in proportion to the area.
